# Winfield Locks

## Failed Embedded Miter Gate Anchorage

Huntington District Corps of Engineers

Feb 2015

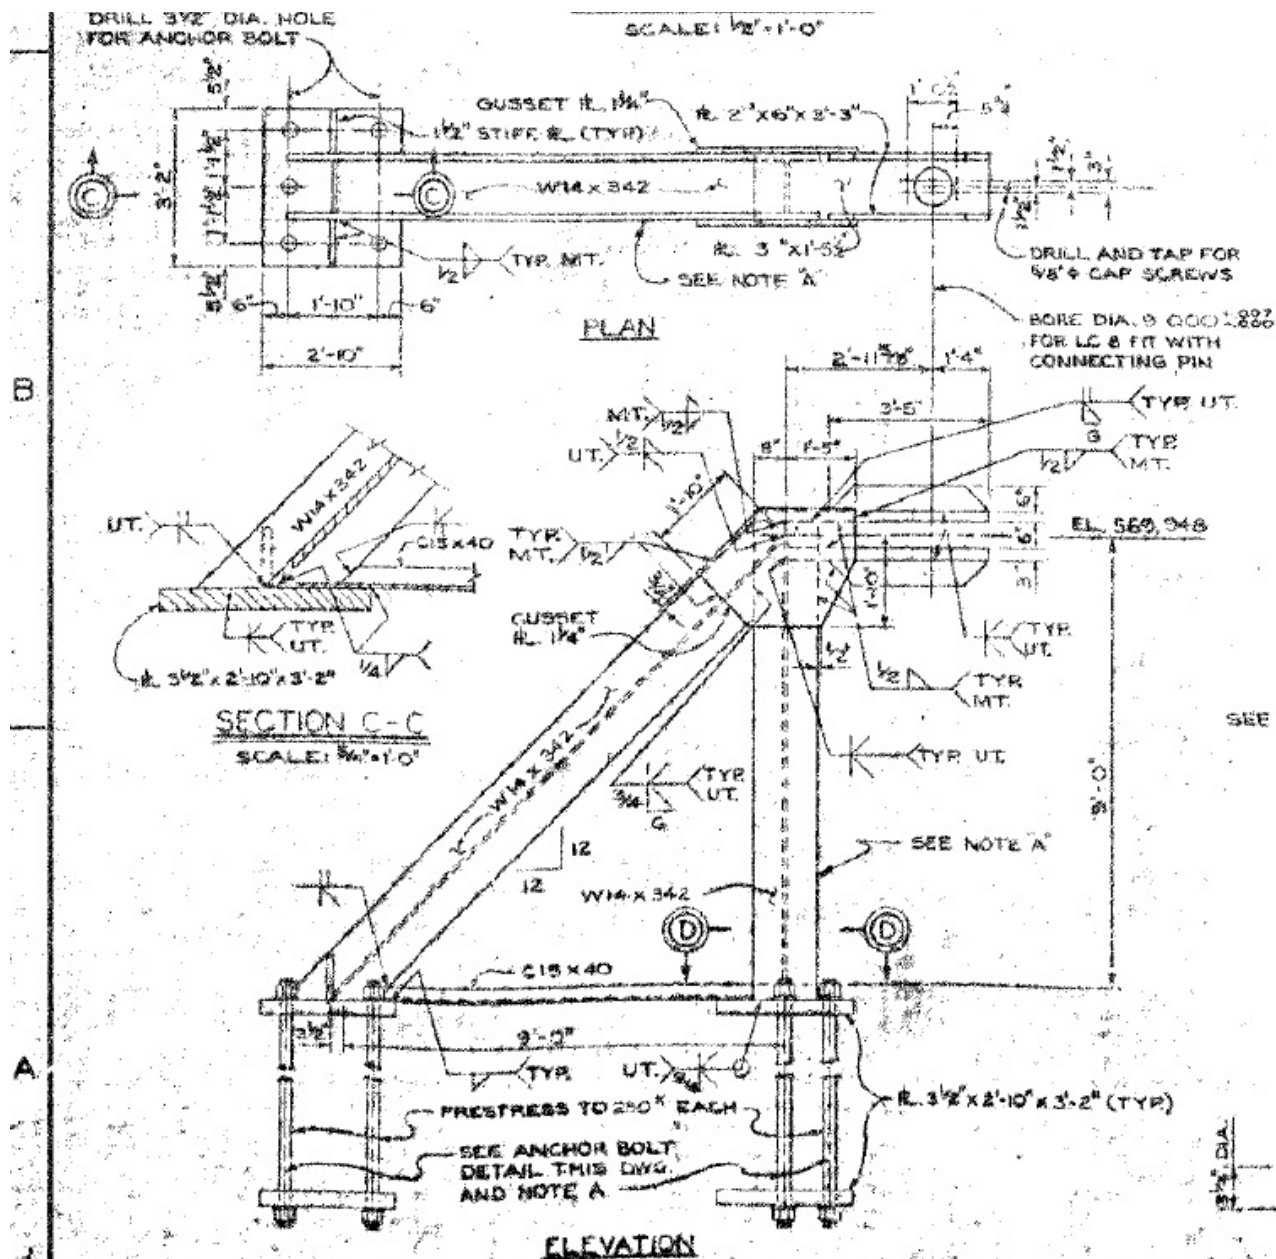
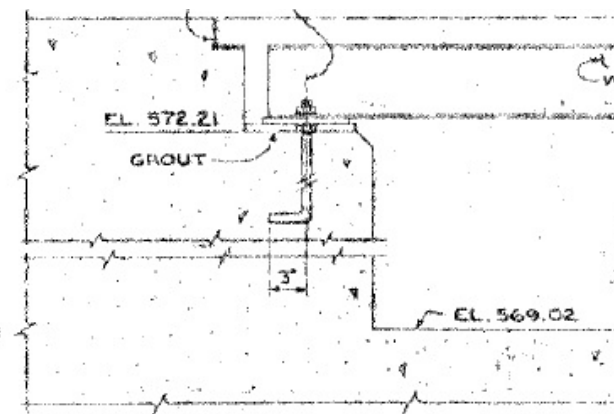
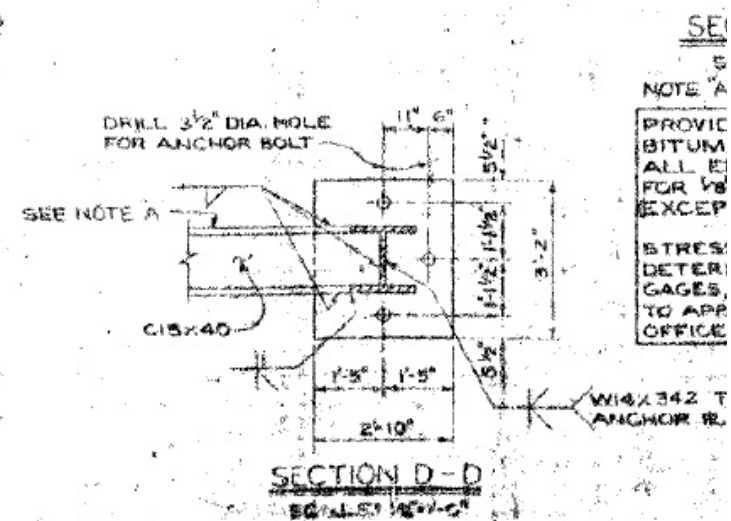
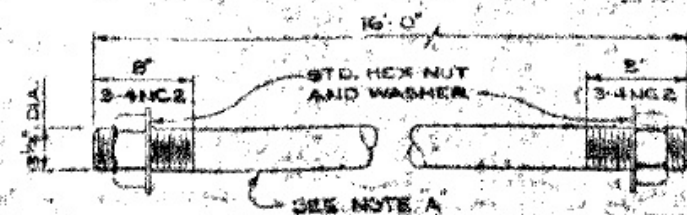
EMBEDDED ANCHORAGE  
STRUCTURAL STEEL ASTM A36-92  
MARK 21/21-1 MAKE B  
SCALE: 1/2"=1'-0"

ANCHOR BOLT  
ASTM A 354-92 GRADE B  
MARK 21/21-2 MAKE 64  
SCALE: 1 1/2" = 1'-0"

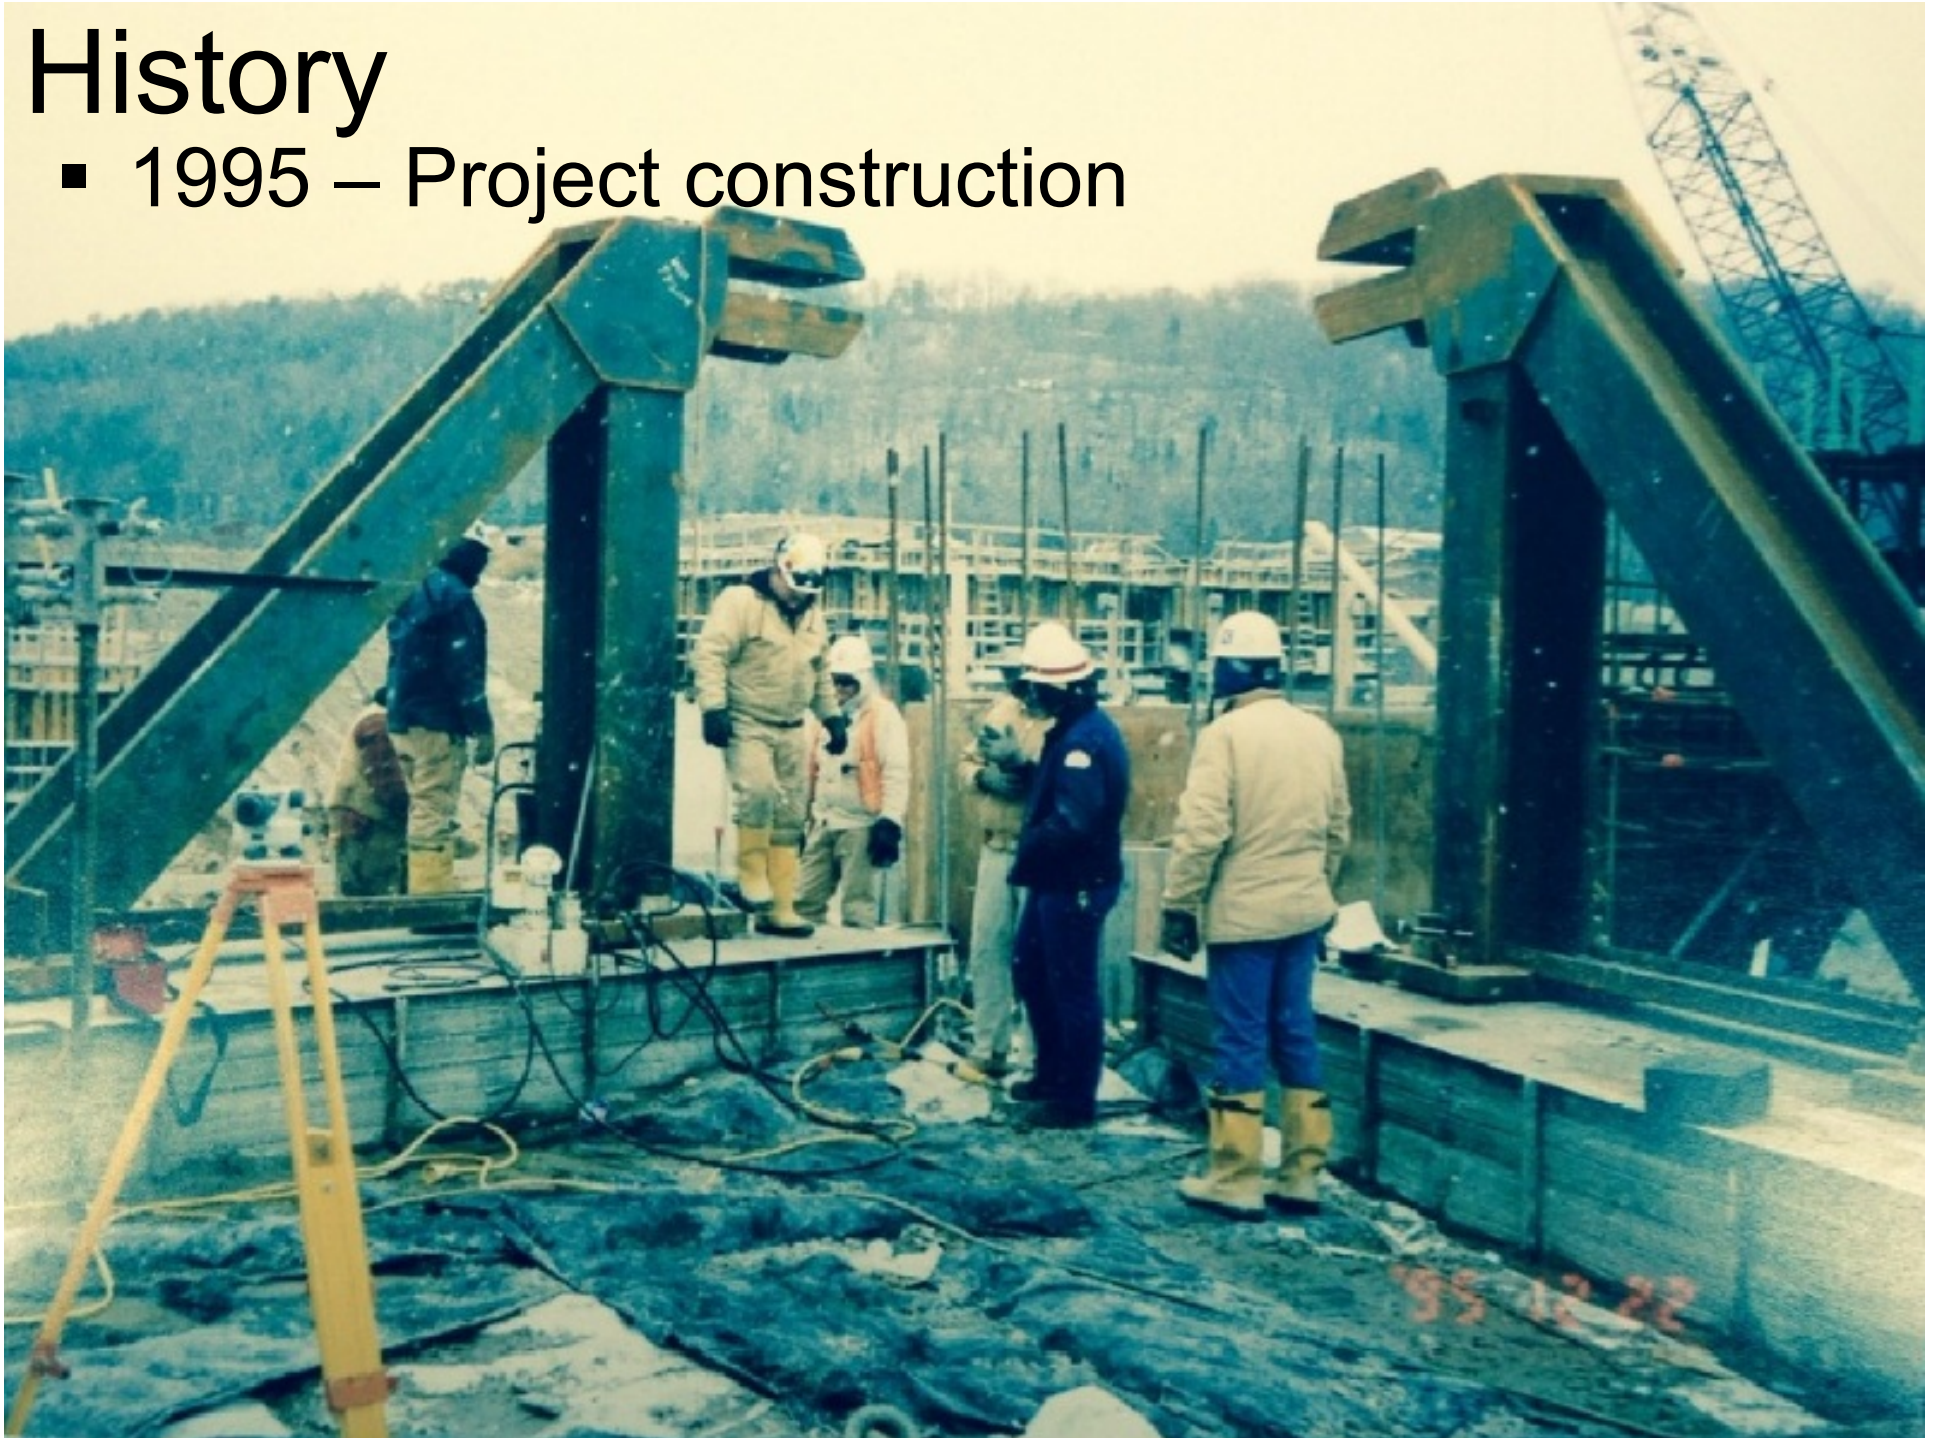
- 1995 – Project construction

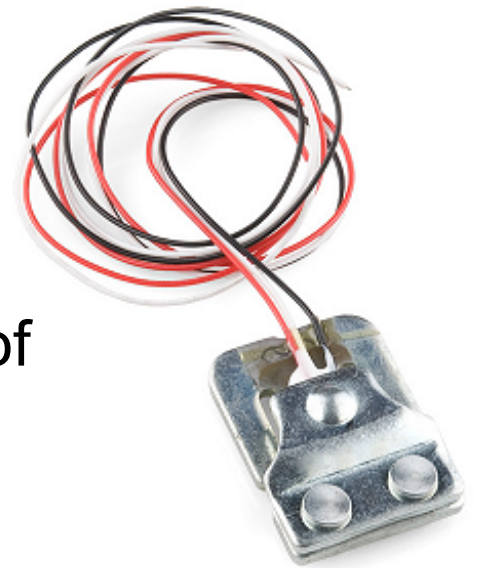
- Project engineers took strain gauge readings of the following. We are interested in seeing the readings after construction is complete.
  - ▶ Gate fully in recess and pressure on cylinder:  $825 \times 10^{-6}$  kips
  - ▶ Gate in recess and pressure released from cylinder:  $720 \times 10^{-6}$  kips
  - ▶ Initial spike when pushing out of recess:  $1200 \times 10^{-6}$  kips
  - ▶ Readings through swing from recess to miter:  
Fluctuates between  $900\text{--}1200 \times 10^{-6}$  kips
  - ▶ Gate in miter position, no head differential, valves 100% open:  
 $1250 \times 10^{-6}$  kips
  - ▶ Gate in miter position, full head differential:  $1055 \times 10^{-6}$  kips
- At this point the anchorage is taking the majority of the load when the gate is in the miter position.

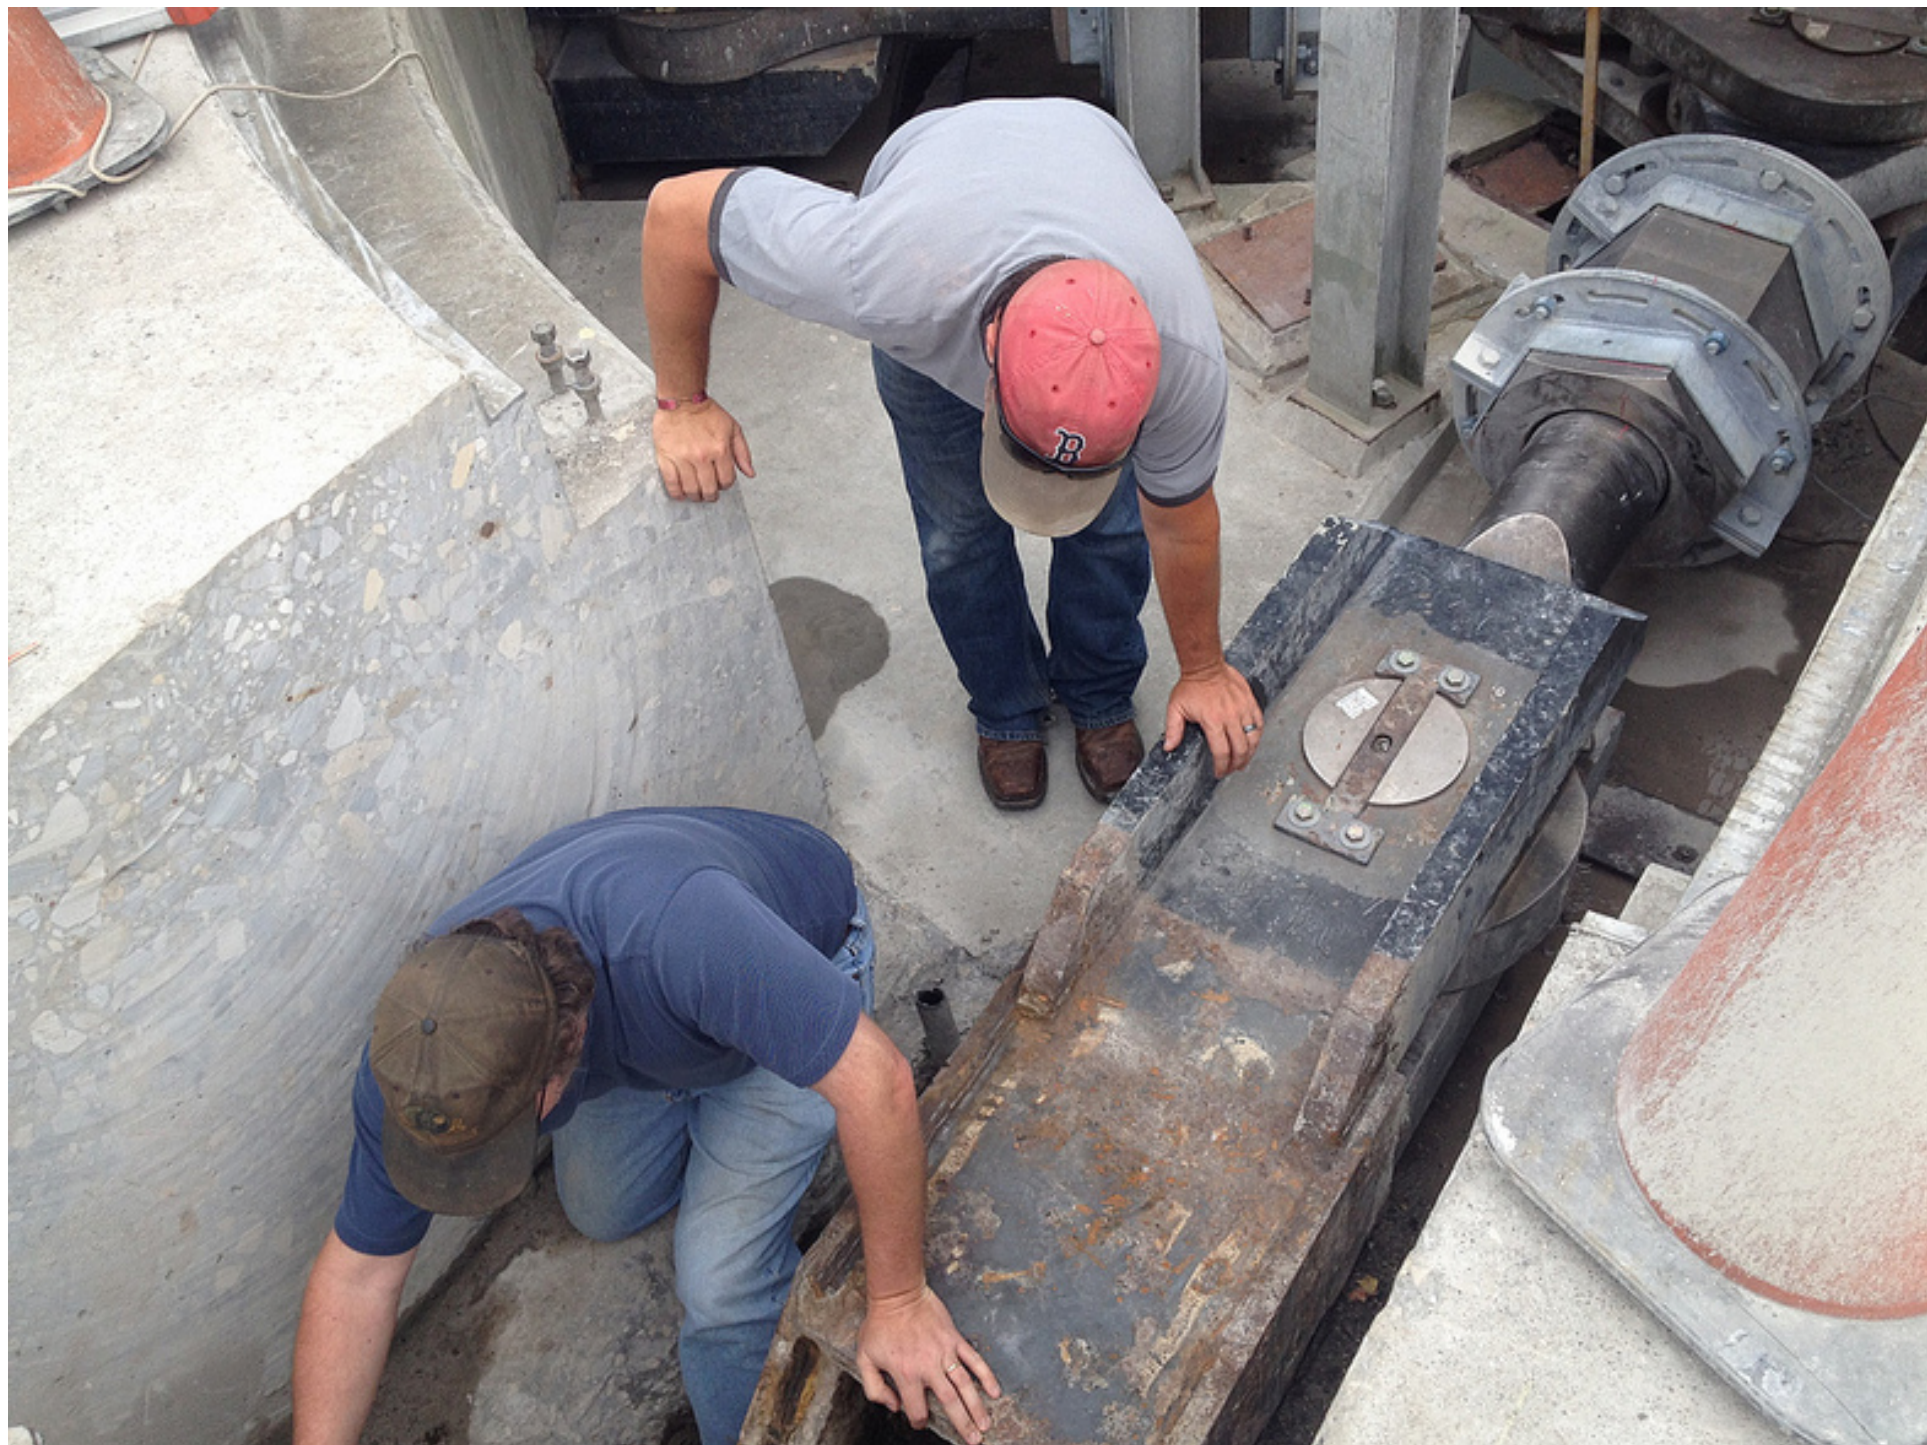
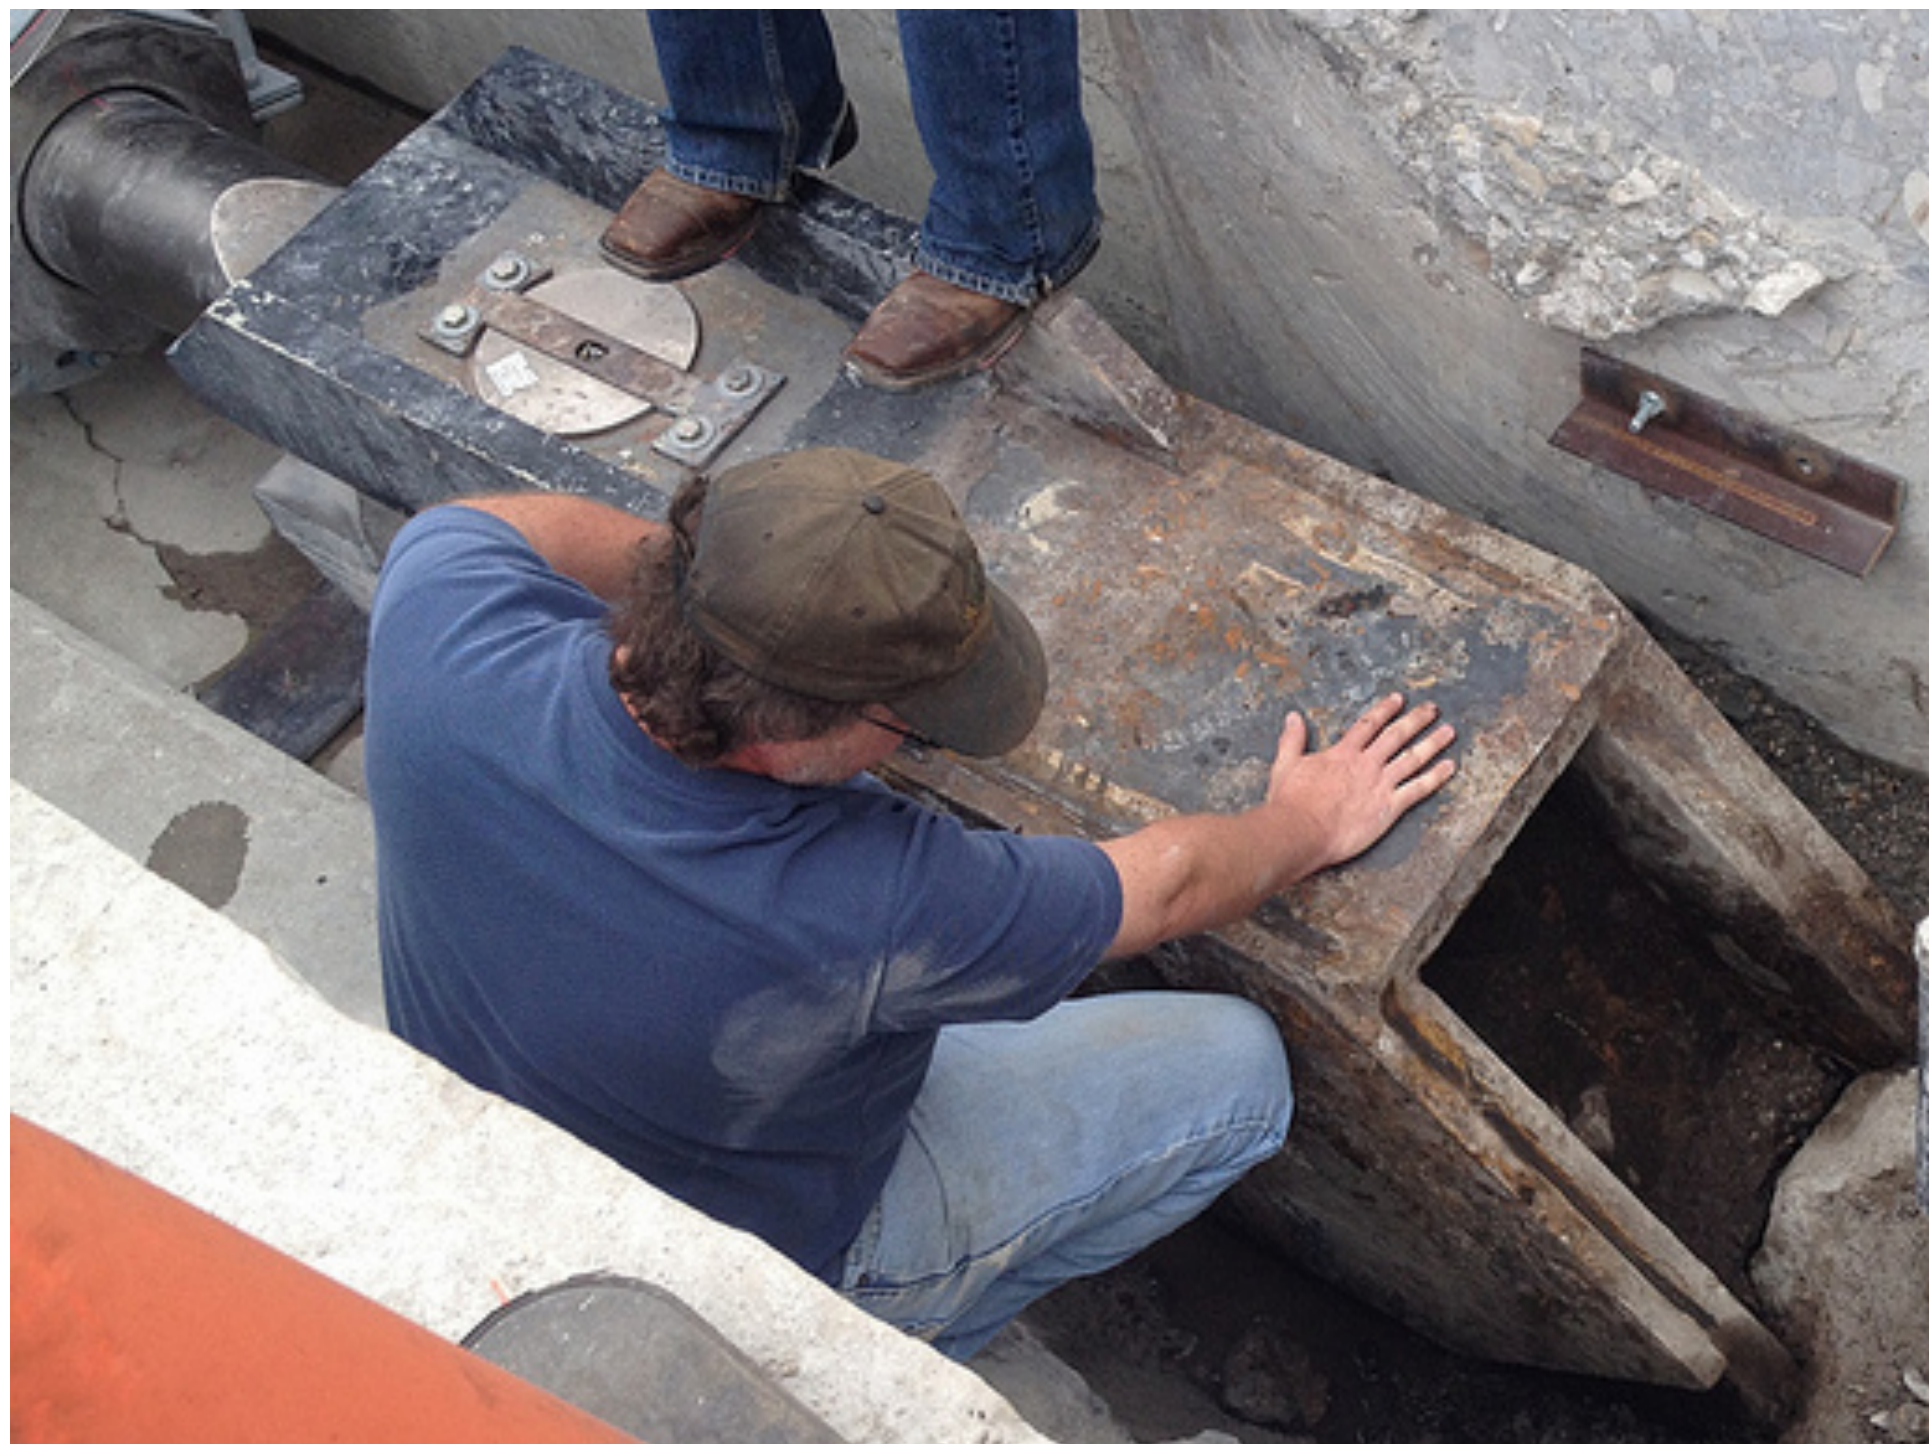
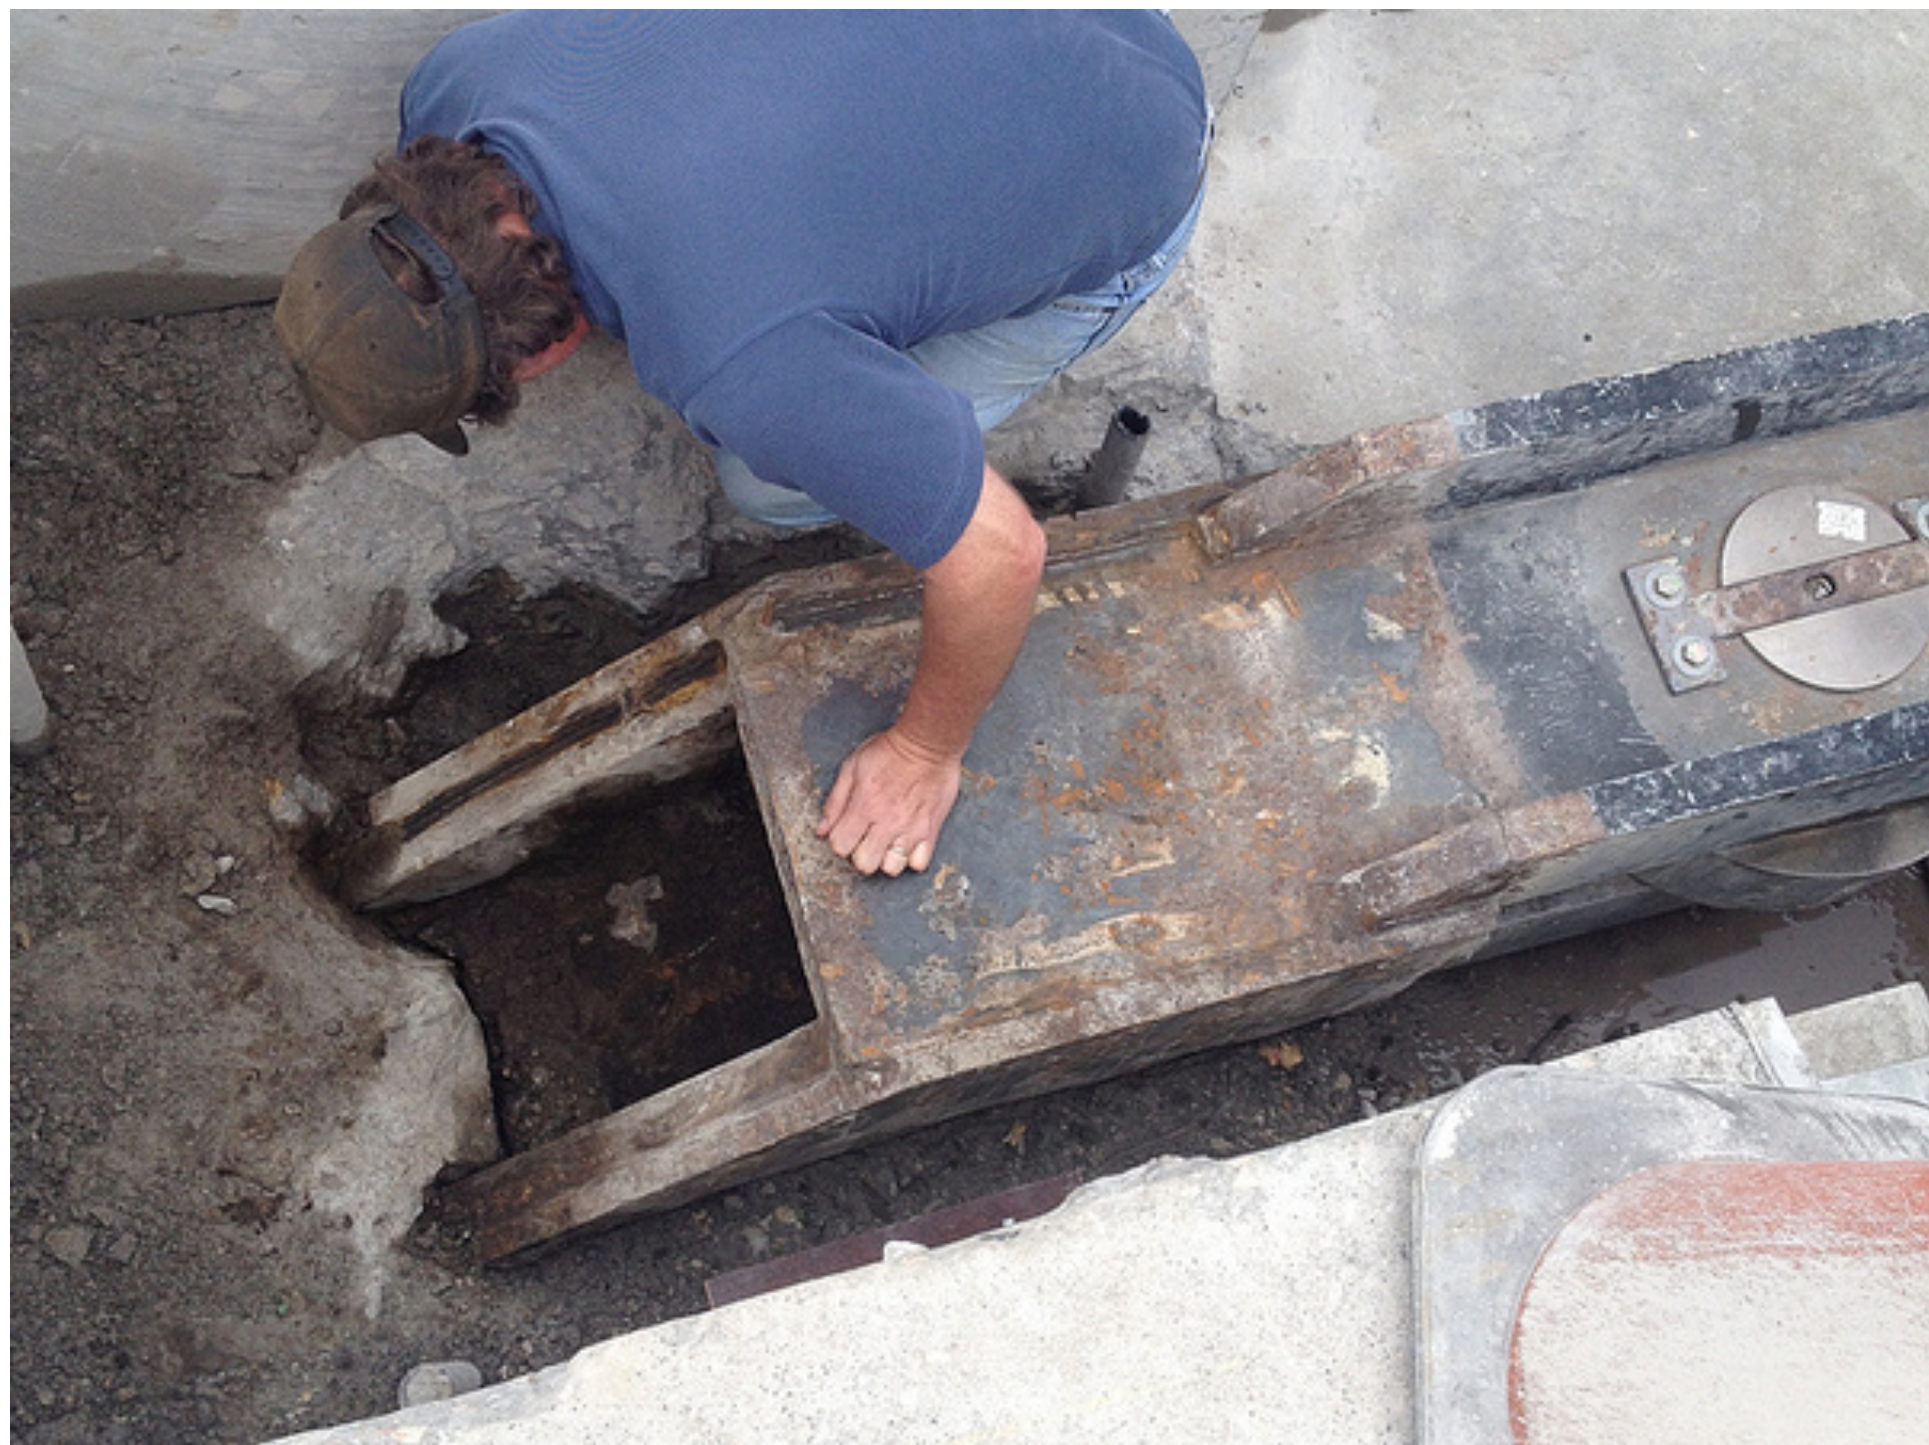
- May 2014 LRL fleet crew removed concrete to expose the top of the embedded anchorage.

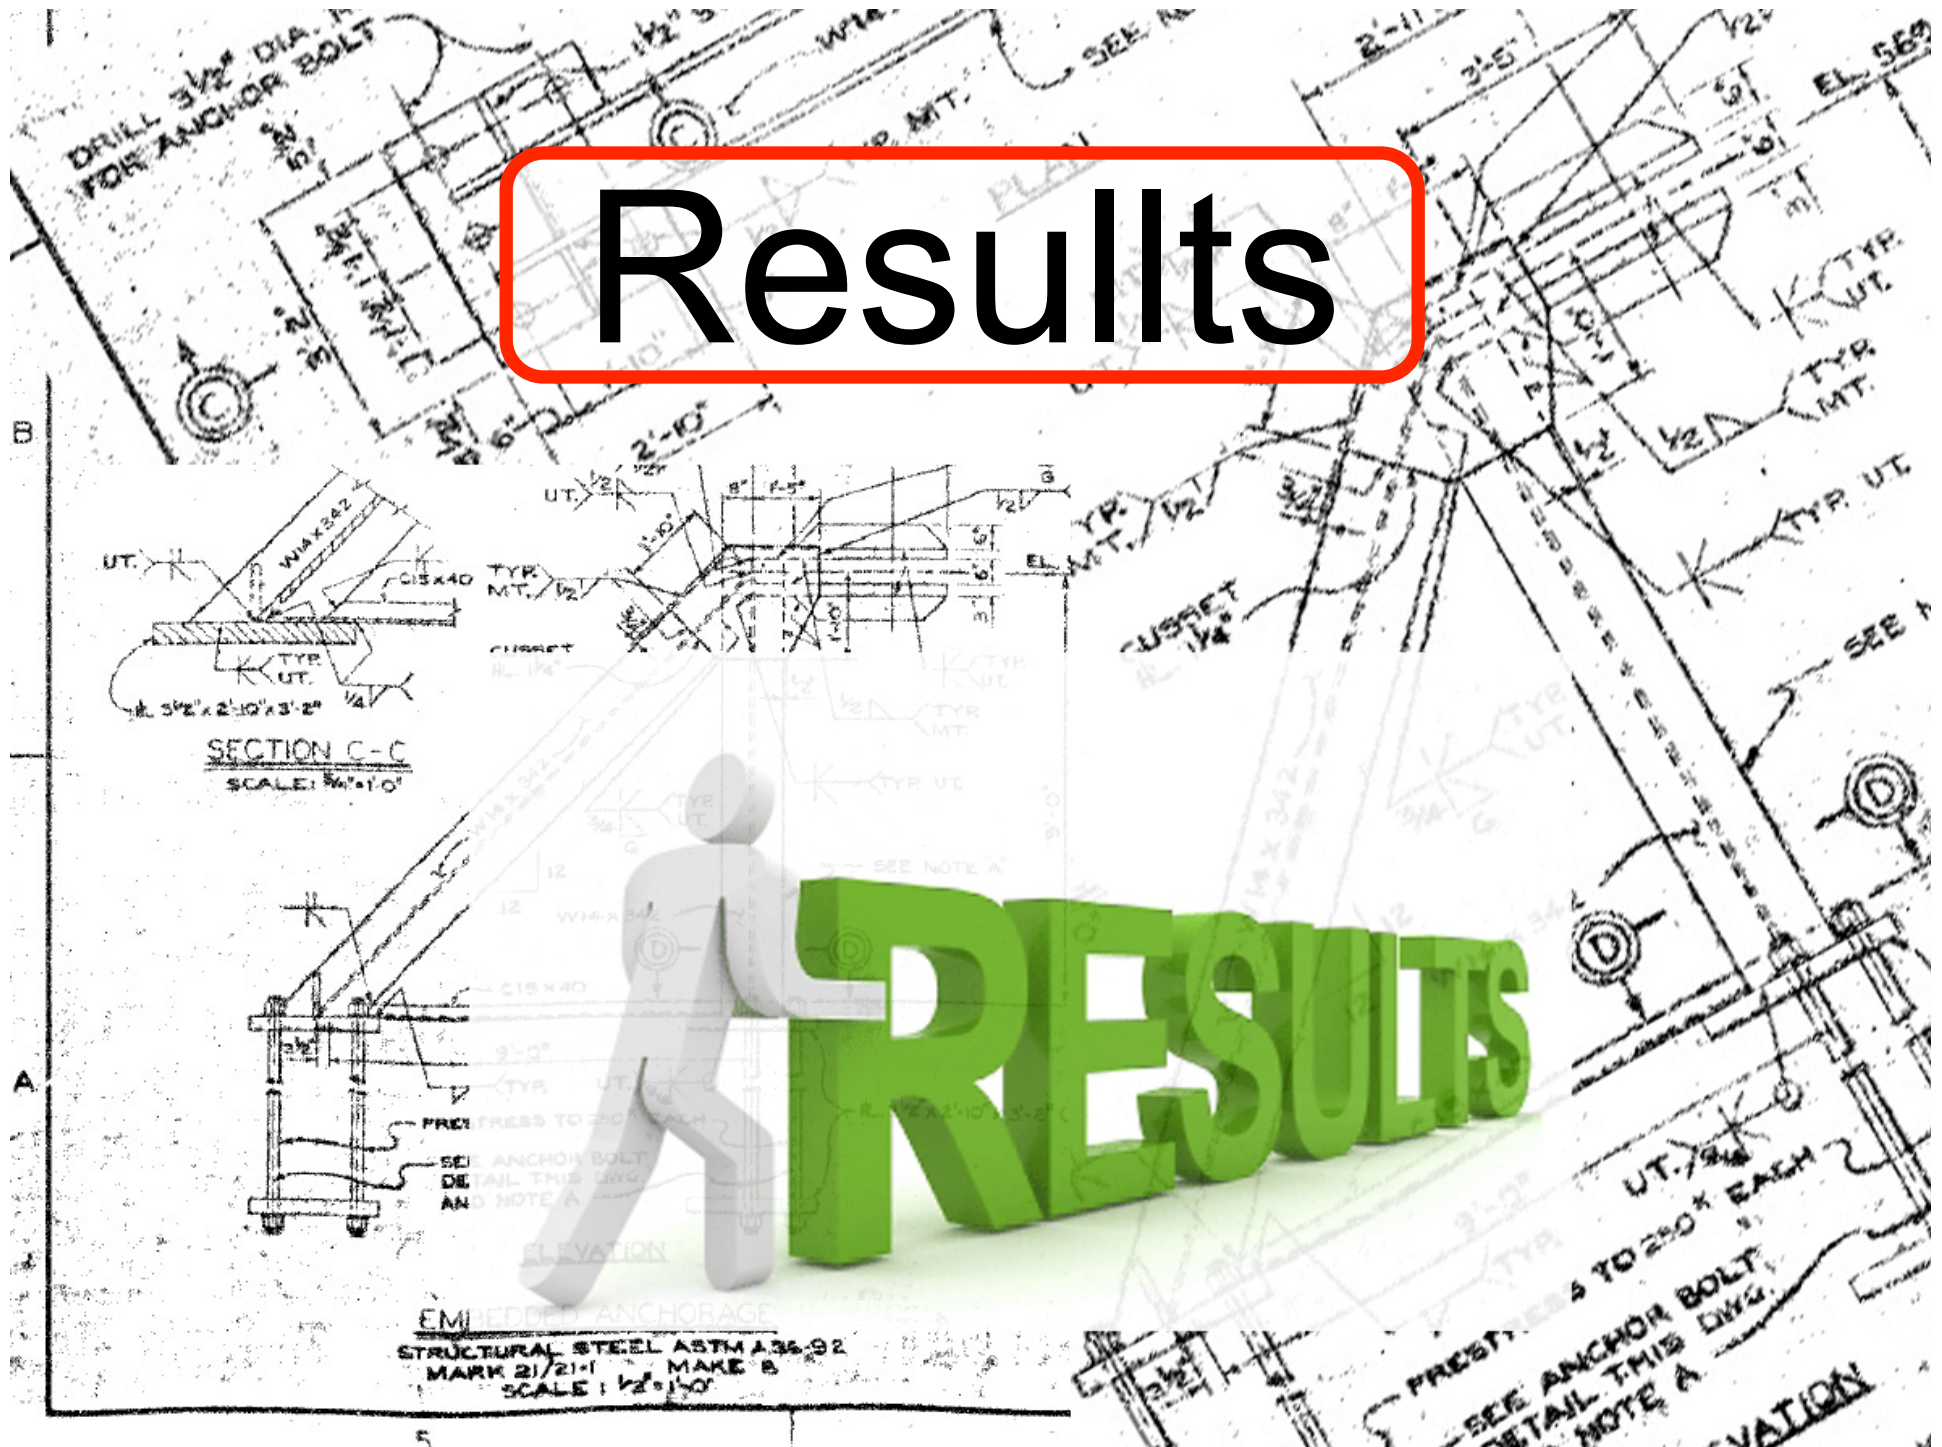
Once roughly 53 cubic yards of concrete was removed from around the embedded anchorage we found there were multiple broken anchorage bolts on the rear of the anchorage
